Type of Incident	Near Miss Personnel Transfer			Intelex Number	48288	
Location / Facility	Marco Polo Hornbeck			Issue Date	01-23-2023	
Contract Company				Short Service Employee Yes D No		No 🛛
Potentially Severe Incident Yes I No I			Significant Incident	Yes 🗆	No 🖾	
Injured Party Information (if applicable): Title/Position: N/A Job Experience at that trade: N/A			Industry Experience in years: N/A Time with company in years: N/A Last safety meeting attended: N/A

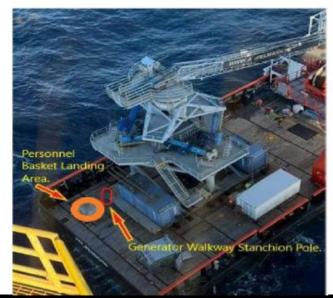
**Description:** At approximately 11:30am, HOS Briarwood Flotel notified the platform about a near miss occurring at 0550am. HOS Briarwood advised during personnel transfer operations, earlier this morning, the personnel basket touched a pole on Generator walkway stanchion just prior to touching down on the deck. Personnel were on the basket at this time, however no injury to personnel occurred, nor did any property damages occur.

After further investigation, it was found the Briarwood Captain made the decision to complete personnel transfers on the AFT of the ship. No "All Stop" was called by Briarwood personnel after near miss occurred. Two more personnel transfers were completed safely to finish the transfer operations.

- Personnel basket transfers, to and from HOS Briarwood, shall only be performed on helideck of the vessel. Any deviation from this, an ALL STOP will be called, and discussed with OIM.
- Ensure proper reporting procedures are communicated between vessels and platform personnel.
- Communications of these immediate improvement actions to be shared with platform management (OIM/TLs), crane operators, and boat captains.
