# SONOCO *Near Miss!*

Date: October 1, 2020 (Redistributed June 29, 2023)

Activity: Operating a Food Grinder

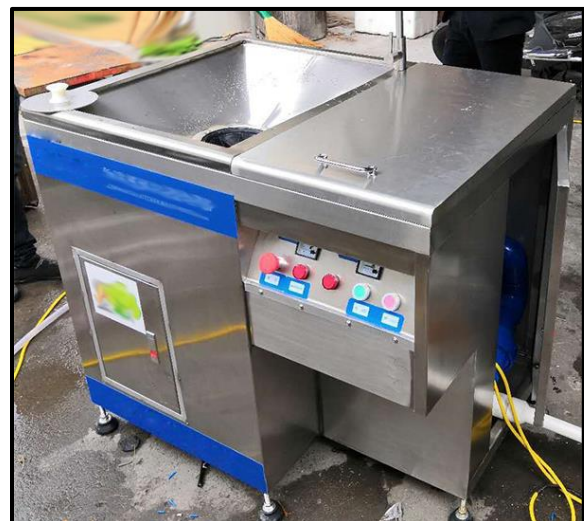
A small piece of bone was ejected from the spinning hopper and it struck the employee's goggles. It could have been worse. For instance, had he not been wearing any goggles at all, he could have sustained an eye injury. Or had it struck his face he could have been badly cut.

So, what were some contributing factors? As you can see from the photo (taken by our team member himself and edited by us to remove location ID), he failed to cover the unit as it was grinding, which allowed it to eject food waste.

We Consider wearing a face shield to be a Best Practice in all circumstances.

**If your location does not have a face shield, please contact our Safety Department and we will arrange to provide one for your location.**
